Outline Condition Survey of Brondanw Arms / Tafarn Y Ring, Llanfrothen

Date of Inspection: 06 January 2025  
Weather Conditions: Light rain, cold 3°C

Issue date: 04 February 2025  
Prepared by: Gethin Roberts  
Checked by: Iwan Thomas

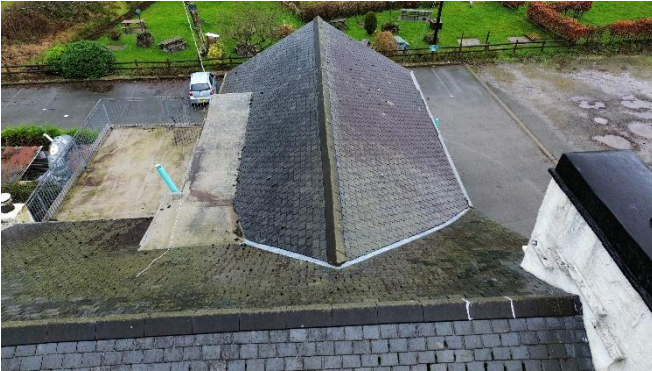
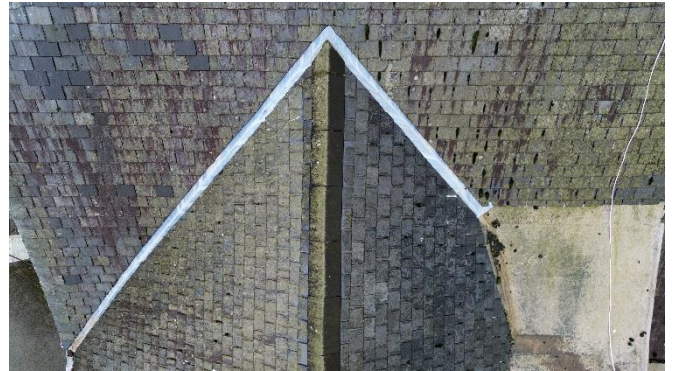
Some moss growth and lichen visible to entire roof. North facing slope cover and ridge tiles are also showing heavy weather / biological growth staining, which is expected due to close proximity of trees along highway. The roof cover appears to be in good condition overall. Flat roofed section in poor condition and appears to have reached its life expiry with moss growth, biological staining and evidence of standing water will little runoff.

- Clean off all moss and biological growth from roof cover.
- Check if sufficient ventilation is provided to pitched roof void and timbers.
- Structural Engineer to assess structural integrity of flat roof structure.
- Replace of flat roof section.

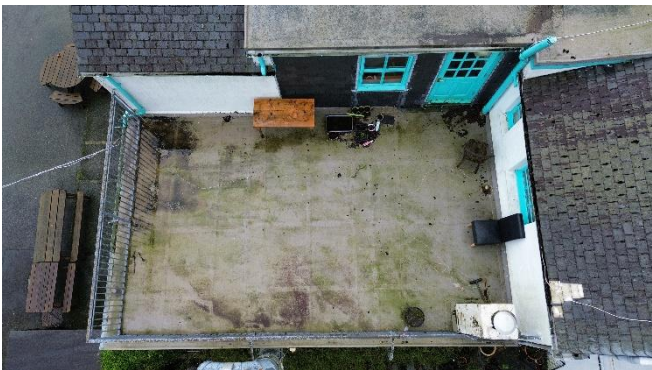
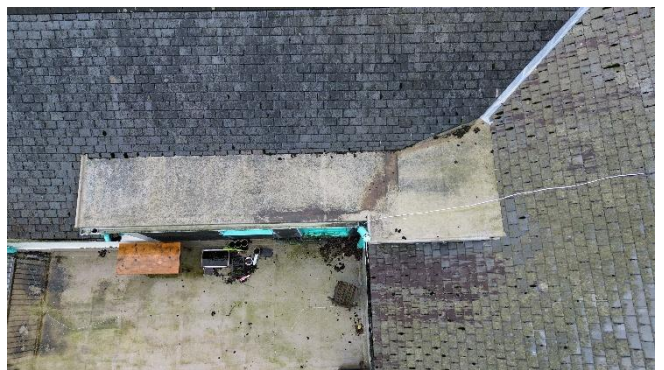
### 8.3.3 Rear Extension's flat roof

Roof is in poor condition and has reached its life expiry with moss growth, biological staining and evidence of standing water with little runoff. Roof structure can be made out from drone images that suggest the deck has failed. Railings appear in satisfactory condition.

- Replace entire flat roof deck and cover.
- Check if sufficient ventilation is provided to roof structure.
- Structural Engineer to assess structural integrity of roof structure. Possible complete replacement of structural timbers is required.

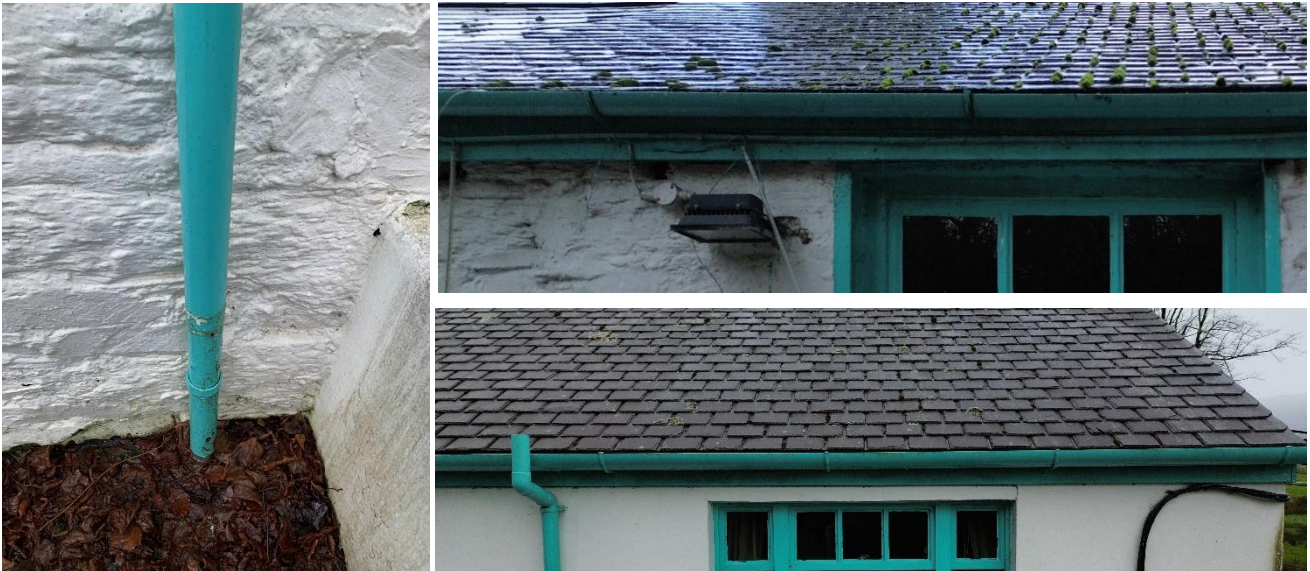
## 8.4 Rainwater Disposal Systems

Generally, all rainwater goods are in satisfactory condition and are well secured to the fascia boards. Downpipes generally discharge into gullies that are likely connected to the mains sewer. Some discharge to surface whilst the ends of other pipes are fixed directly into the ground and are encased with hardstanding (tarmac and concrete). The UPVC rainwater goods are unsympathetic to the building.

- Regularly clear out gutters and gullies of blockages. Consider fixing brushes or gratings to gutters to prevent buildup of leaves and vegetation growth.
- Flush out rainwater and surface water drainage system.
- Replace UPVC rainwater goods (RWGs) with cast iron or cast aluminium RWGs.
- Allow to repair/replace sections of cast iron RWGs like-for-like. Redecorate with suitable metal paint.

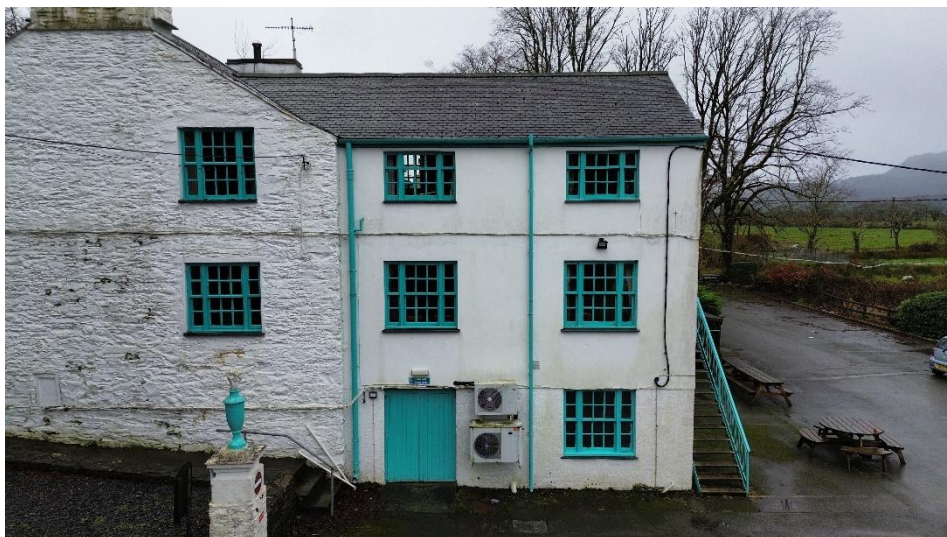
The render is generally in good condition with evidence of localized patch repairs to the lower ground floor level. Paintwork is also sound but weather stains are visible, especially to the lower ground level and to the corner of the extension from top to bottom.

- Remove moss and biological growth to textured render at low level and from tarmac surface to at least 1m from building to prevent further damage.
- Patch repair damaged areas of textured render at low level.
- Redecorate entire façade with suitable masonry paint.
- Consider re-routing telephone and TV cabling to be less visible if possible to minimize visual impact on the appearance of the historic building.

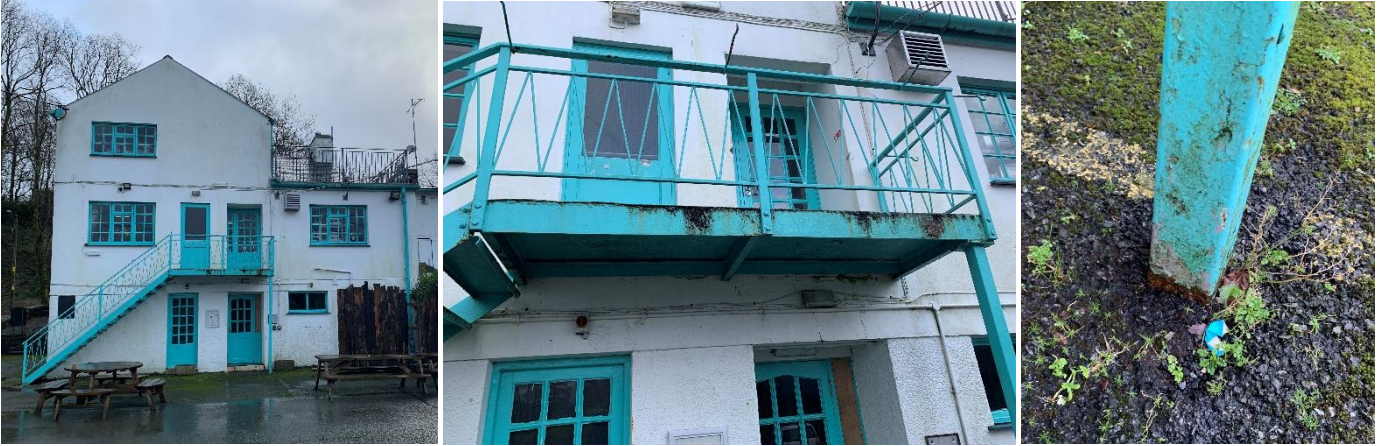
### 8.5.4 Section 04 (North-West Elevation)

The render is generally in good condition with evidence of localized patch repairs to the lower ground floor level. Paintwork is also sound but weather stains are visible, especially to the lower ground level and to the corner of the extension from top to bottom. Paintwork coating to the steel staircase has largely failed and damaged exposing the underlying steel to moisture and oxygen, which has led to rust formation / corrosion to some areas of the landing's trimmer and the base of the supporting post.

- Remove moss and biological growth to textured render at low level and from tarmac surface to at least 1m from building to prevent further damage.
- Patch repair damaged areas of textured render at low level.
- Redecorate entire façade with suitable masonry paint.
- Consider re-routing telephone and TV cabling to be less visible if possible to minimize visual impact on the appearance of the historic building.
- Repair galvanized steel stairs by cleaning off corrosion / rust formation and redecorating with suitable paint.

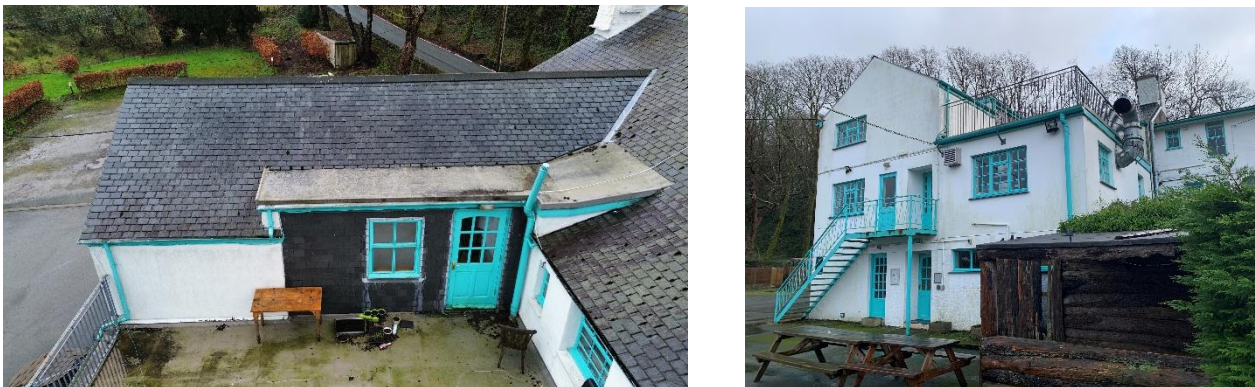
#### 8.5.5 Section 05 (South-West Elevation)

The render is generally in good condition with some weather staining visible. Slate cladding is generally intact with some staining below the window cill and around the external door frame.

- Remove staining from slate cladding.
- Consider new protruding cill to window with sufficient drip detail to prevent further staining to slate cladding.

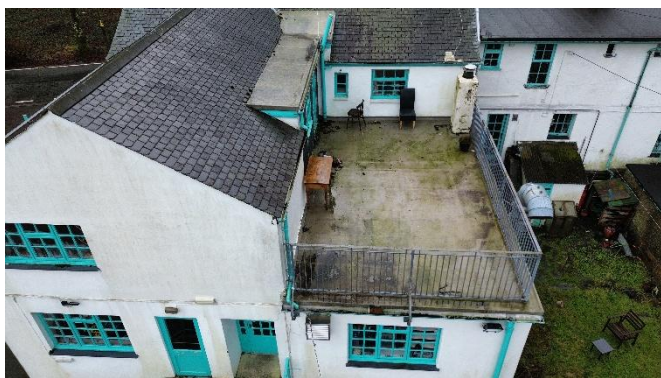
### 8.5.6 Section 06 (South-West Elevation)

The render appears to be cementitious and is showing signs of age with localized hairline cracks and some weather staining in places. It is suspected that some of the plaster may have debonded in places. The cementitious render is likely to be withholding moisture within the solid walls thus preventing the passage of moisture which is not allowing the walls to breathe. Along with its age, this also is likely to be the root cause of the cracks.

- Investigations to determine if render is cementitious in nature. If so, remove render back to stonework and render over in suitable lime-based plaster once wall has sufficiently dried out. Should there be gypsum / cementitious plaster on the inside walls then this should also be removed and replaced with a traditional lime-based plaster to allow the wall to fully breathe. Decorate both sides of the walls with breathable paint such as limewash or similar.

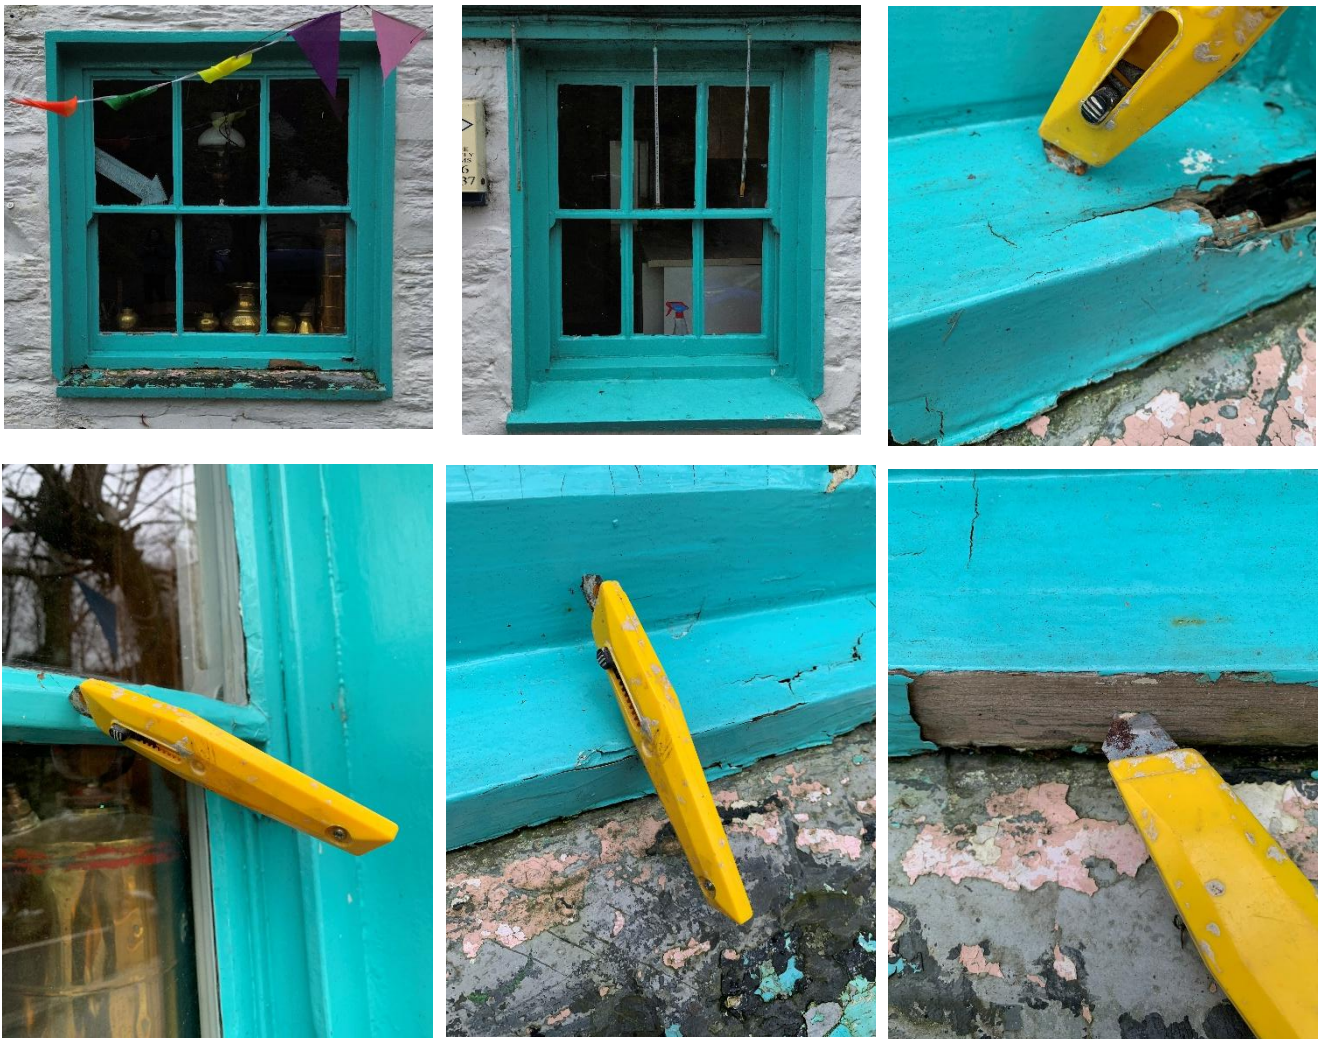
### 8.6.1 South-East Elevation (Principle / Front Facade)

Generally, in poor condition with paintwork failing with hairline cracks and flaking prevalent suggesting the paint is plastic / impervious thus not allowing the passage of moisture. This has caused the timber to rot in places, especially lower down the frames. The bottom rails and timber cills have decayed and will need to be fully replaced. Most of the glazing putty has also perished and will need to be replaced in its entirety. Some sash / glazing bars are also soft suggesting they have decayed beyond repair. Window may have been painted shut. The rendered reveals are in a reasonable condition.

- Remove as much of the impervious paint as possible insitu, preferably down to bare wood – this may require removing entire window out to be factory repaired.
- Allow to gently ease sticking sashes and excess paint removed. Replace sash weights, cords and pulley wheels to window. Also replace glazing putty and consider installing brush seals and draught proofing strips.
- Replace all timber cills entirely like-for-like to all windows. Allow to splice repair 25% with new timber.
- Redecorate windows with suitable breathable paint such as linseed oil paint to existing colour.
- Allow for new ironmongery and sash cords, pulleys and weights.

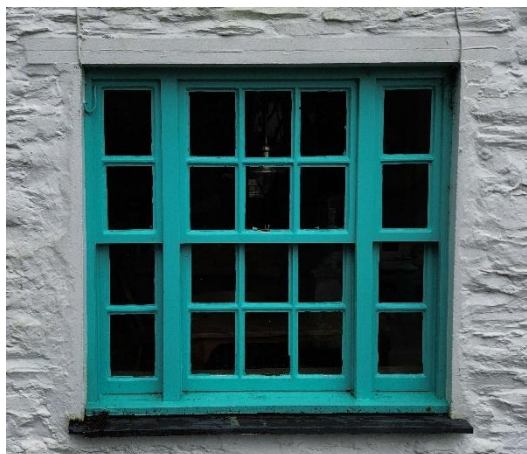
### 8.6.2 North-East Elevation (Side Facade)

Generally, in good condition. Similar to all other windows, the same paint has been applied which is showing signs of failing with hairline cracks and some flaking suggesting the paint is plastic / impervious and is therefore not allowing the passage of moisture. The timber cill to the lower ground floor window has begun to rot and looking at drone photos it appears the same problem applies to the remaining windows to this elevation. The glazing putty to all windows appear in fair condition with some hairline cracking visible which suggests it's reaching its life expiry. Sash / glazing bars appear to be in sound condition.

- Remove as much of the impervious paint as possible insitu, preferably down to bare wood.
- Allow to gently ease sticking sashes and replace sash weights, cords and pulley wheels to window. Also replace glazing putty and consider installing brush seals and draught proofing strips.
- Replace all timber cills entirely like-for-like to all windows. Allow to splice repair 10% with new timber.
- Redecorate windows with suitable breathable paint such as linseed oil paint to existing colour.
- Allow for new ironmongery and sash cords, pulleys and weights.
