Outline Condition Survey of Brondanw Arms / Tafarn Y Ring, Llanfrothen

Date of Inspection: 06 January 2025  
Weather Conditions: Light rain, cold 3°C

Issue date: 04 February 2025  
Prepared by: Gethin Roberts  
Checked by: Iwan Thomas

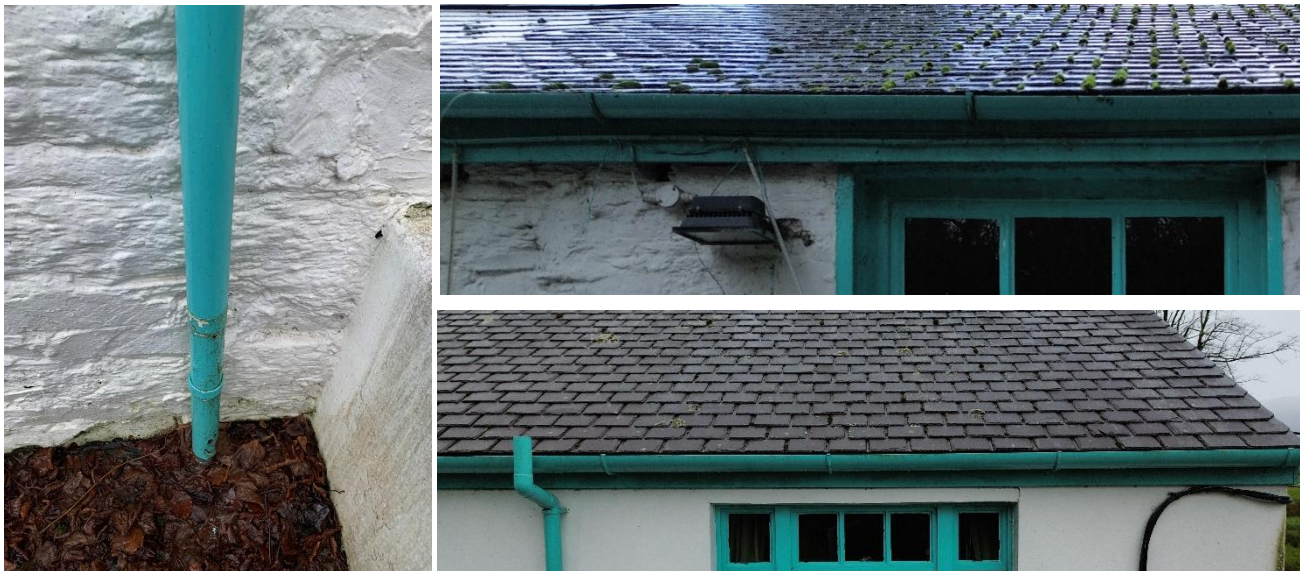
## 8.4 Rainwater Disposal Systems

Generally, all rainwater goods are in satisfactory condition and are well secured to the fascia boards. Downpipes generally discharge into gullies that are likely connected to the mains sewer. Some discharge to surface whilst the ends of other pipes are fixed directly into the ground and are encased with hardstanding (tarmac and concrete). The UPVC rainwater goods are unsympathetic to the building.

- Regularly clear out gutters and gullies of blockages. Consider fixing brushes or gratings to gutters to prevent buildup of leaves and vegetation growth.
- Flush out rainwater and surface water drainage system.
- Replace UPVC rainwater goods (RWGs) with cast iron or cast aluminium RWGs.
- Allow to repair/replace sections of cast iron RWGs like-for-like. Redecorate with suitable metal paint.

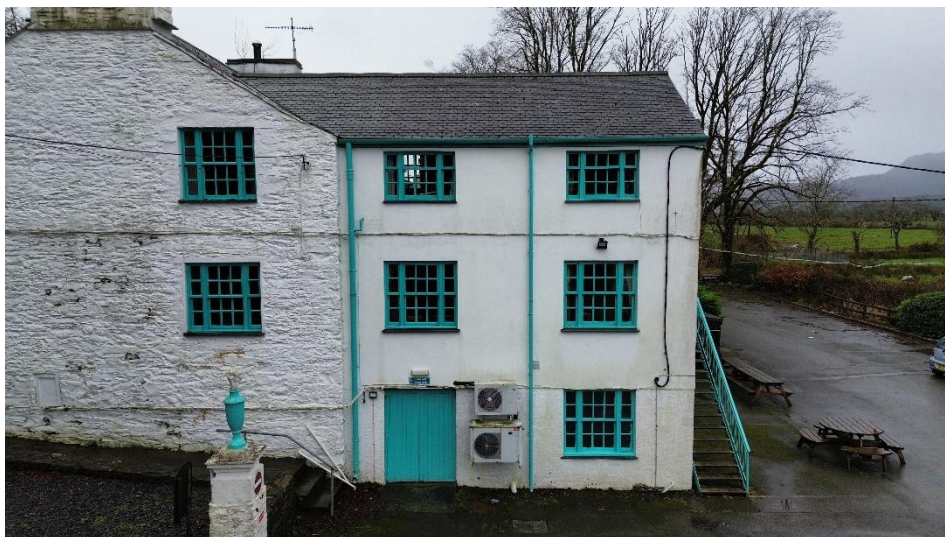
The render is generally in good condition with evidence of localized patch repairs to the lower ground floor level. Paintwork is also sound but weather stains are visible, especially to the lower ground level and to the corner of the extension from top to bottom.

- Remove moss and biological growth to textured render at low level and from tarmac surface to at least 1m from building to prevent further damage.
- Patch repair damaged areas of textured render at low level.
- Redecorate entire façade with suitable masonry paint.
- Consider re-routing telephone and TV cabling to be less visible if possible to minimize visual impact on the appearance of the historic building.

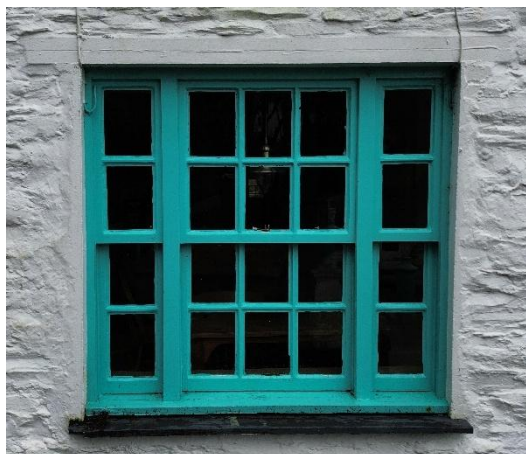
### 8.6.2 North-East Elevation (Side Facade)

Generally, in good condition. Similar to all other windows, the same paint has been applied which is showing signs of failing with hairline cracks and some flaking suggesting the paint is plastic / impervious and is therefore not allowing the passage of moisture. The timber cill to the lower ground floor window has begun to rot and looking at drone photos it appears the same problem applies to the remaining windows to this elevation. The glazing putty to all windows appear in fair condition with some hairline cracking visible which suggests it's reaching its life expiry. Sash / glazing bars appear to be in sound condition.

- Remove as much of the impervious paint as possible insitu, preferably down to bare wood.
- Allow to gently ease sticking sashes and replace sash weights, cords and pulley wheels to window. Also replace glazing putty and consider installing brush seals and draught proofing strips.
- Replace all timber cills entirely like-for-like to all windows. Allow to splice repair 10% with new timber.
- Redecorate windows with suitable breathable paint such as linseed oil paint to existing colour.
- Allow for new ironmongery and sash cords, pulleys and weights.

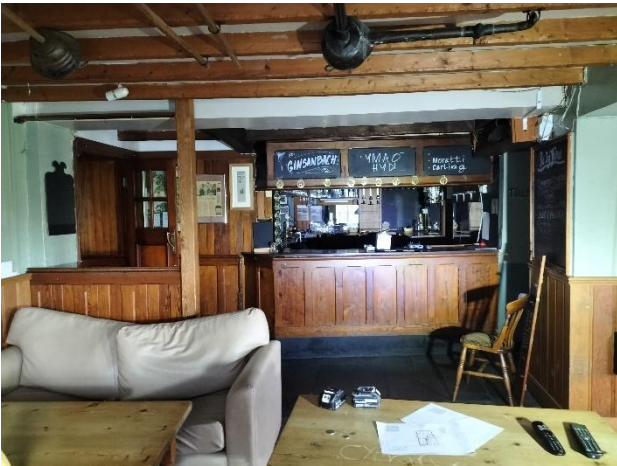
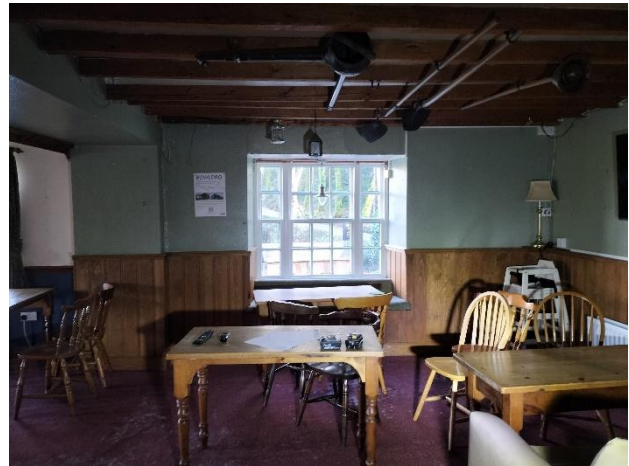
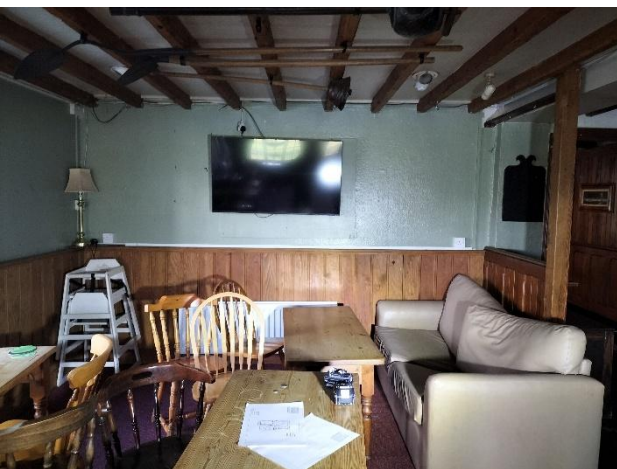
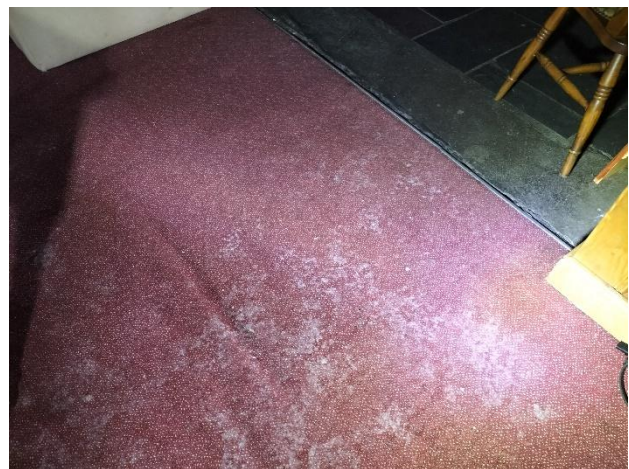
**Ceiling** | Joisted floor over with plaster infill between joists that are papered over with painted woodchip wall paper. Generally in good condition but not overly sympathetic. Similar to Bar Bach, the exposed joists appear to be relatively modern.

- Investigate plaster build up to external wall (north).
- Redecorate walls and ceilings.
- Replace carpet and underlay. Alternatively, replace with engineered wooden flooring.
- Overhaul window as described in section 8.6.2.
