Outline Condition Survey of Brondanw Arms / Tafarn Y Ring, Llanfrothen

Date of Inspection: 06 January 2025  
Weather Conditions: Light rain, cold 3°C

Issue date: 04 February 2025  
Prepared by: Gethin Roberts  
Checked by: Iwan Thomas

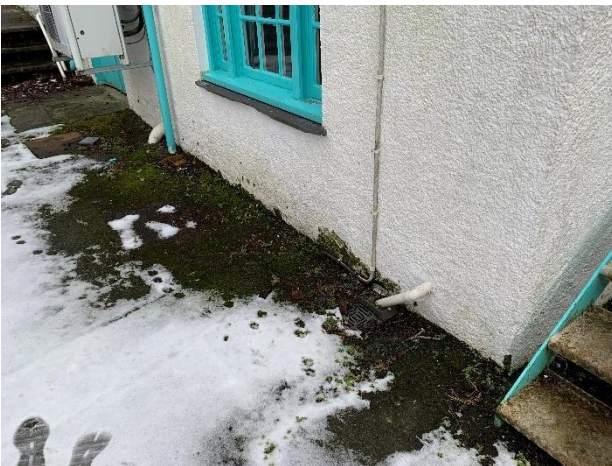
Moss growth to tarmac surface to building perimeter.

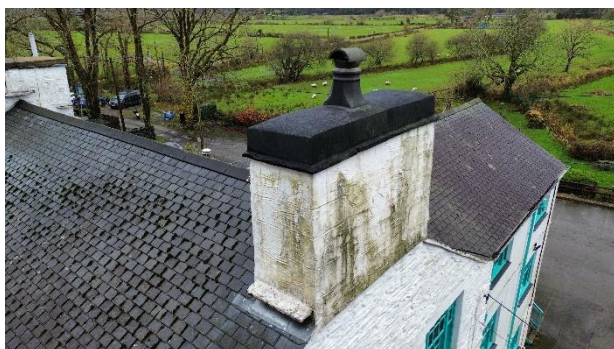
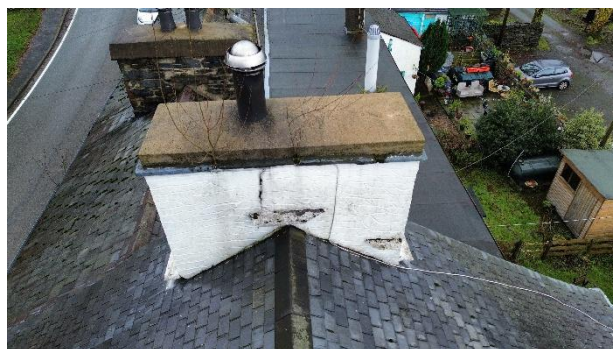
Render to north gable stack is heavily stained below concrete capping which is suspected to be contributing to damp issues to northern gable wall. Render to both stacks are unsympathetic and detrimental to the character of the building. Render appears in sound condition but is suspected to be cementitious plaster that is likely to be withholding moisture that may be contributing to the damp issues to the northern gable wall. Concrete capping to southernmost stack has cracks visible that may be allowing water into the stacks' masonry.

- Hack off render and rake out mortar joints.
- Re-point with traditional lime-based mortar.
- If stonework is in good condition then limewash over with 4no coats. If not, dub out and render over stonework with traditional lime-based plaster.
- Allow to replace concrete capping to southernmost stack with NHL5 lime mortar.
- Line stacks / flues with lime-based mortar.
- Allow for new flues and vented caps.

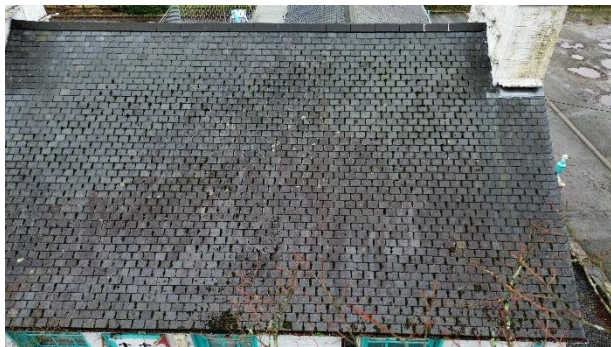
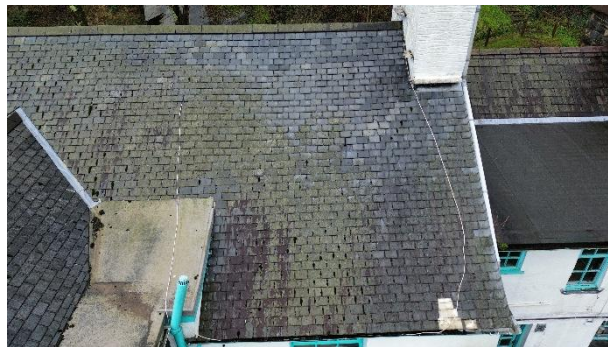
### 8.3.1 Main / Original Building

Heavy moss growth and some lichen visible, especially to the front (eastern) pitched slope. Rear (western) slope cover and ridge tiles are also showing heavy weather / biological growth staining, which is expected due to close proximity of trees along highway. There is also evidence of several localized repairs to the rear slope with lead cleats visible which suggests possible nail sickness / failure – this is likely to result in the need to re-roof the entire slope within the next 5-10 years as the roof slope is nearing its life expiry. Some ridge tiles have also been re-bedded towards the northern end of the ridge as fresh mortar joints are visible. The roof structure seems to be relatively modern and in good condition with very little of the original roof structure remaining, mainly perkins which are doubled up with new members. Mineral wool insulation appears in satisfactory condition but may need additional insulation to reach suitable standards for accommodation. Suspect that roof void currently does not have sufficient ventilation, which could lead to the decay of the roof structure.

- Clean off all moss and biological growth from roof cover.
- Re-roof entire rear slope. Allow for new roofing sheet membrane. May need to be Type 1F felt if presence of roosting bats, which will also require form of clear ventilation between eaves and ridge levels. Lead vents may need to be provided if eaves and ridge vents alter the external appearance of the roof.
- Re-bed all ridge tiles with NHL3.5 lime mortar.
- Structural Engineer to assess structural integrity of roof structure. New ceilings joists and roof ties especially to be thoroughly examined.

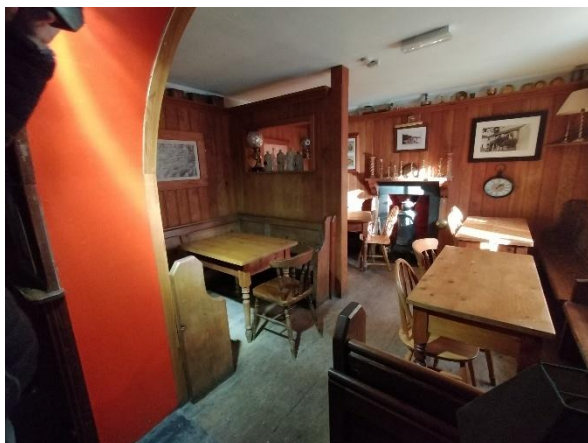
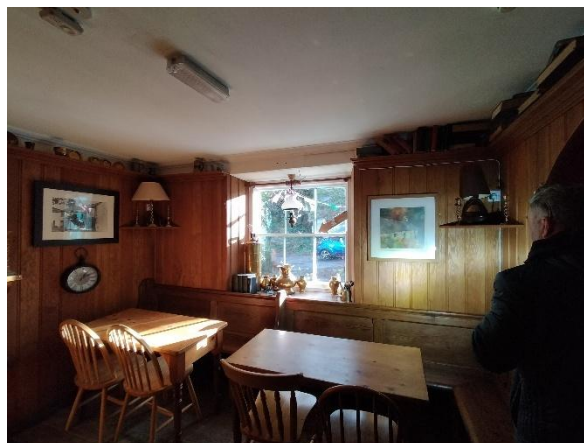
#### Overview photos:

### 9.2.2 G02 – Parlwr Bach

**Ceiling** | Smooth painted plaster on timber joists with classical styled modern plastered covings. Generally in good condition.

**Walls** | Modern T&G boarding obscuring solid, mass masonry walls and single partition to west wall. Boarding stops short of ceiling by c.200mm with book shelf detail to perimeter. Generally in good condition.

**Floor** | Suspended timber floor with wide timber boarded finish. Boards are in satisfactory condition considering their age, but are showing signs of wear with several indents and scratches visible all over.

**Windows** | Likely 19<sup>th</sup> century sliding sash timber window with painted finish. Paintwork is tired and window will need to be overhauled as sash is stiff. Refer to section 8.6.1 for full description and external condition and recommended repair details.

**Features** | Original fireplace recess with modern wood burner and slate tiled surround with timber shelf incorporated into T&G cladding. Generally in good condition. Timber cart wheel fixed within wall opening between Parlwr Bach and the entrance passage, which is in good condition.

- Overhaul window as described in section 8.6.2.
- Apply protective coating over timber boarded flooring.
- General clean to walls and floors.
- Redecorate walls to window reveals and ceilings.

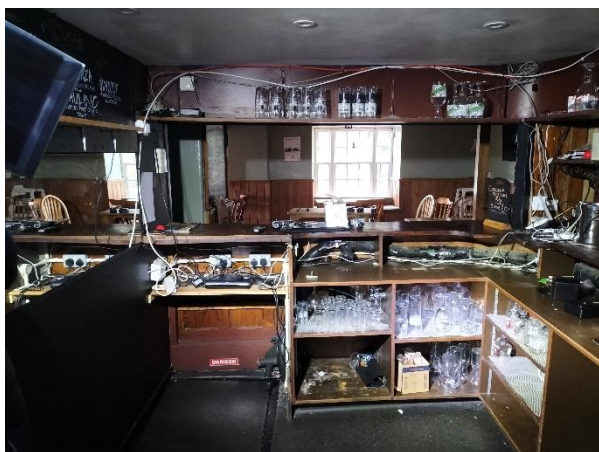
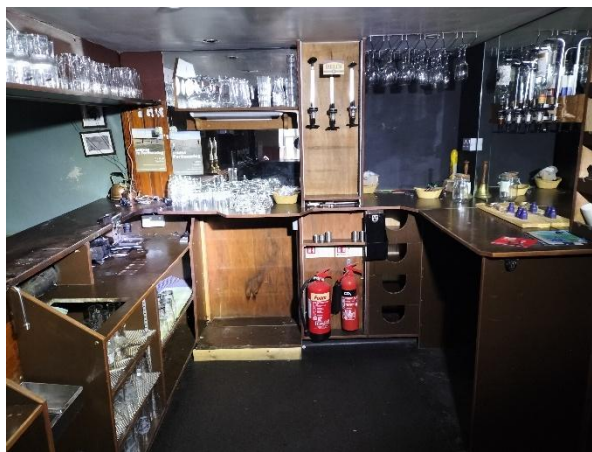
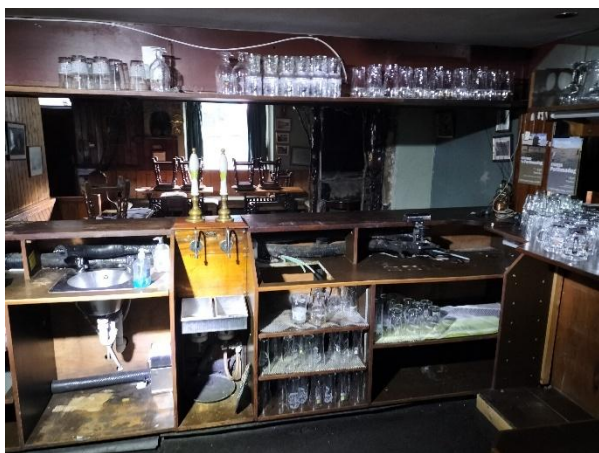
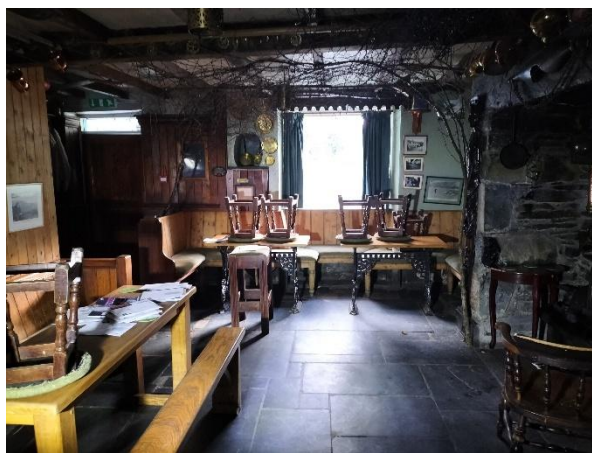
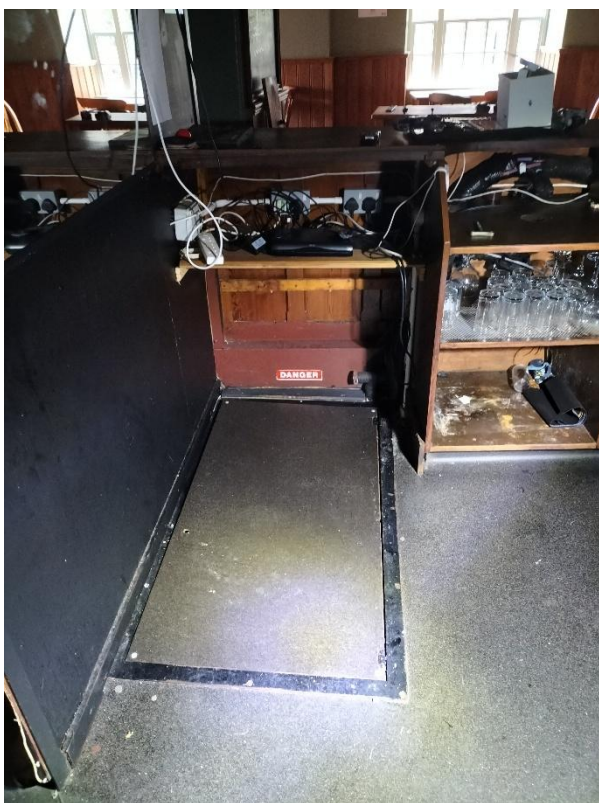
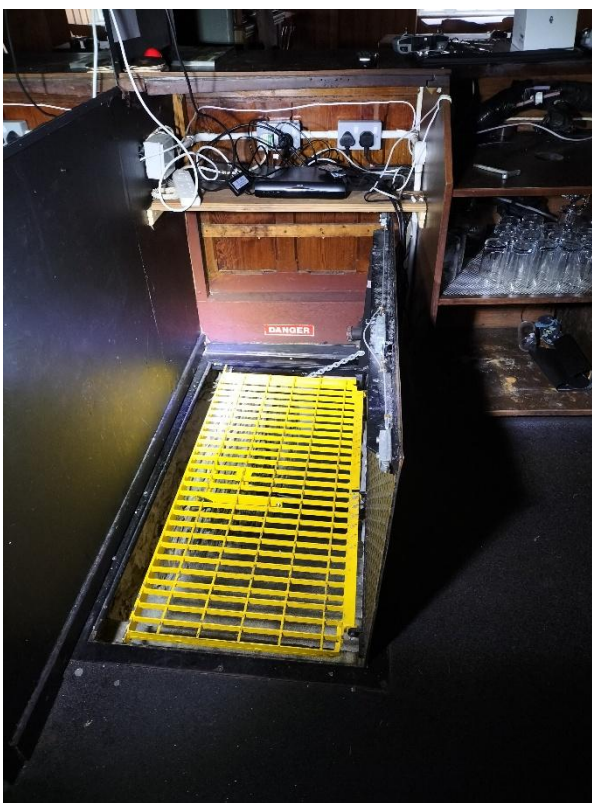
Overview photos:

### 9.2.3 G03 – Bar

**Ceiling** | Smooth painted plaster on timber joists. Generally in good condition.

**Walls** | Solid, mass masonry walls with plaster finish that's papered over with painted woodchip wall paper and largely obscured by wooden paneling and mirrors therefore it was not possible to assess condition of walls. Paneling and shelving appears tired and worn with a lot of staining visible.

**Floor** | Suspended timber floor with assumed timber sheet deck. Vinyl sheet flooring finish with mixture of coved and modern timber skirtings. Vinyl is in fair condition and is a little worn in places and largely stained all over.

**Door** | Single leaf plain solid timber fire door with varnish finish, vision panel at high level and modern ironmongery. In satisfactory condition.

**Features** | Varnished timber paneling to exterior of bar and timber worktop along the frontage of the bar in good condition considering their age. Cellar hatch with gas strut assistor. Hatch is in two layers with a solid wooden panel lid finished with vinyl matching the floor finish that closes onto a painted steel mesh base, both of which are held open with gas strut assistors and are in good condition.

- Replace vinyl flooring with similar new waterproof flooring. Assess condition of deck and allow to replace if necessary.
- Clean internal paneling and shelving. Although they are fine to use in the short term, they will need to be upgraded within the next 5-10 years.
- Consider replacing fire door with a more sympathetic design.

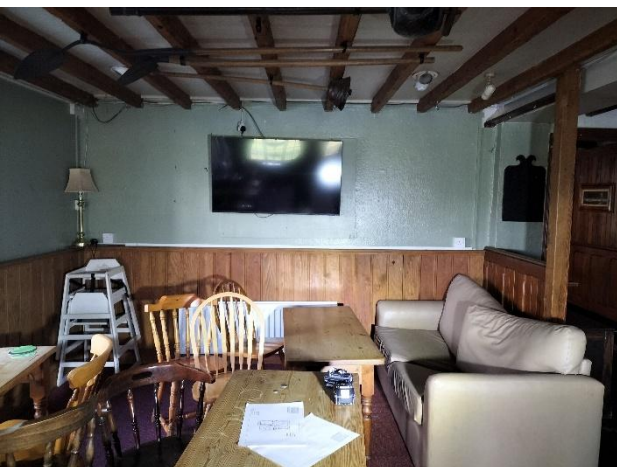
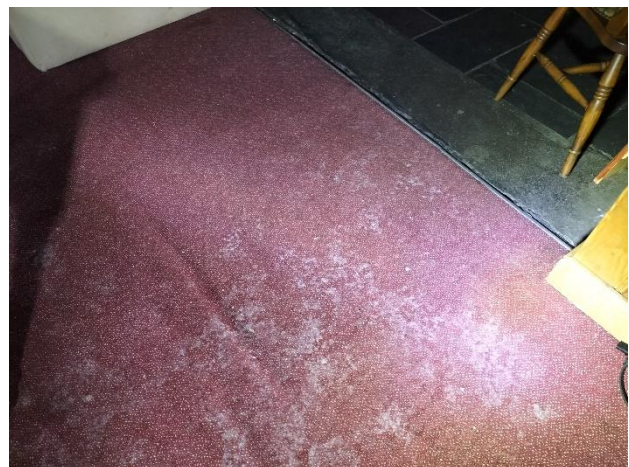
**Overview photos:**

**Ceiling** | Joisted floor over with plaster infill between joists that are papered over with painted woodchip wall paper. Generally in good condition but not overly sympathetic. Similar to Bar Bach, the exposed joists appear to be relatively modern.

**Walls** | Solid, mass masonry walls with obscured to bottom half with modern T&G boarding and skirting, and plaster finish to top half that's papered over with painted woodchip wall paper. Timber paneling is in good condition but paintwork to plaster seems a little tired. It is suspected that the external wall (north) may have been replastered with sand and cement sometime in the 1980's, which will need to be further investigated.

**Floor** | Large slate flags with mortar joints and randomly laid on solid construction to area in front of bar. Although some scratches are visible to the flags, they are generally in good condition considering their age. Suspended timber floor with assumed timber boarded deck and carpet finish. Carpet is in poor condition with mould patches all over and is tired, worn and lifting in places. This is mainly due to its age but also because of the lack of heating and ventilation over the past 3-4 months.

**Windows** | One painted sliding sash single glazed window. Window is not original but is in satisfactory condition. Refer to section 8.6.2 for description of external condition.

- Investigate plaster build up to external wall (north).
- Redecorate walls and ceilings.
- Replace carpet and underlay. Alternatively, replace with engineered wooden flooring.
- Overhaul window as described in section 8.6.2.

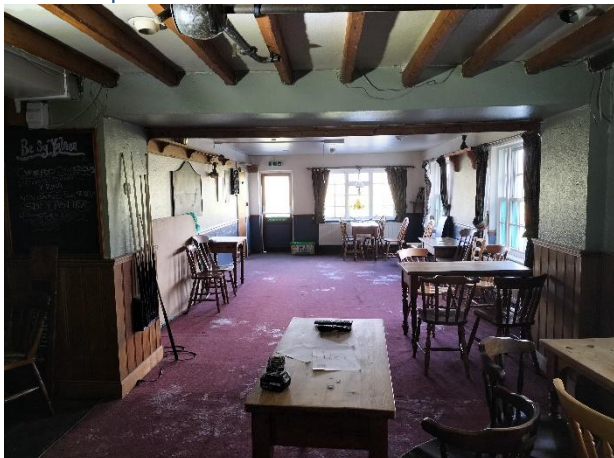
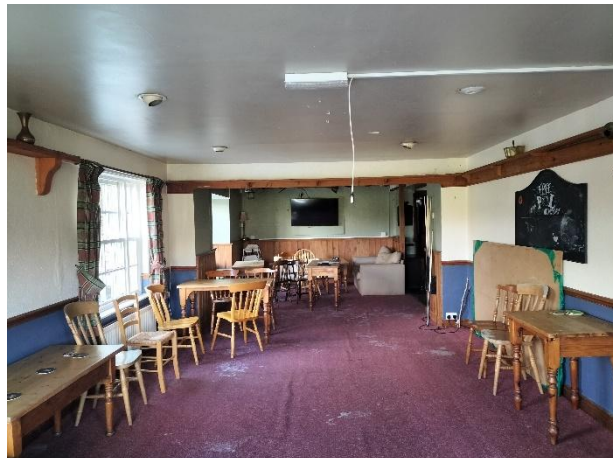
#### Overview photos:

### 9.2.5 G04b – Lownj Gefn

**Ceiling** | Smooth painted plaster on timber joists. Generally in good condition.

**Walls** | Cavity masonry walls with painted plaster papered over with painted woodchip wall paper and dado rail half way up wall. Plaster generally in good condition with decoration a little tired and in need of refreshing. A small section of wall paper has blistered on the north wall and will need investigating.

**Floor** | Suspended timber floor with assumed timber boarded deck and carpet finish. As with G04a, carpet is in poor condition with mould patches all over and is tired, worn and lifting in places. This is mainly due to its age but also because of the lack of heating and ventilation over the past 3-4 months.

**Windows** | One painted sliding sash single glazed window. Window is not original but is in satisfactory condition. Refer to section 8.6.2 for description of external condition.

**Door** | Fire exit doors, one internally and the other external escape door. Internal door is plain solid timber door with varnish finish and modern ironmongery, which appears to be in satisfactory condition but is unsympathetic. Refer to section 8.7.3 for description and condition of external door.

**Features** | High level plain timber shelving to flanking walls, generally in good condition.

- Redecorate walls and ceilings.
- Replace carpet and underlay. Alternatively, replace with engineered wooden flooring.
- Overhaul windows as described in section 8.6.2.
- Consider replacing internal fire door with a more sympathetic design.

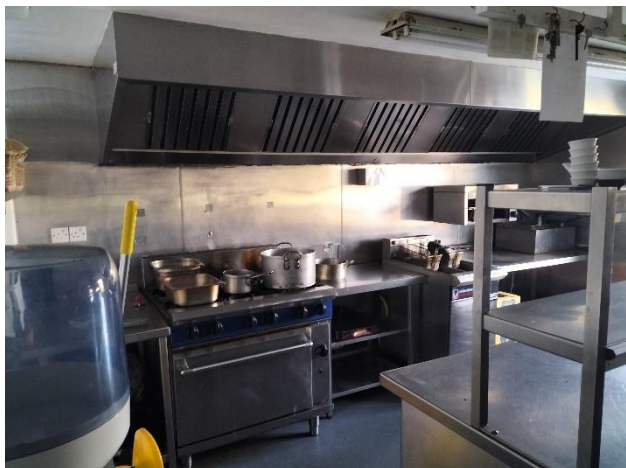
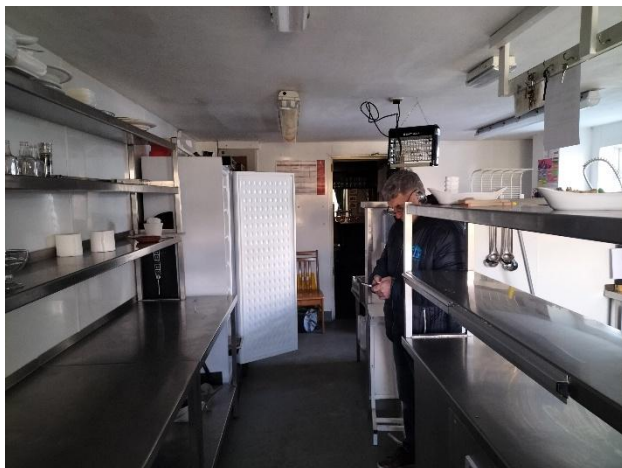
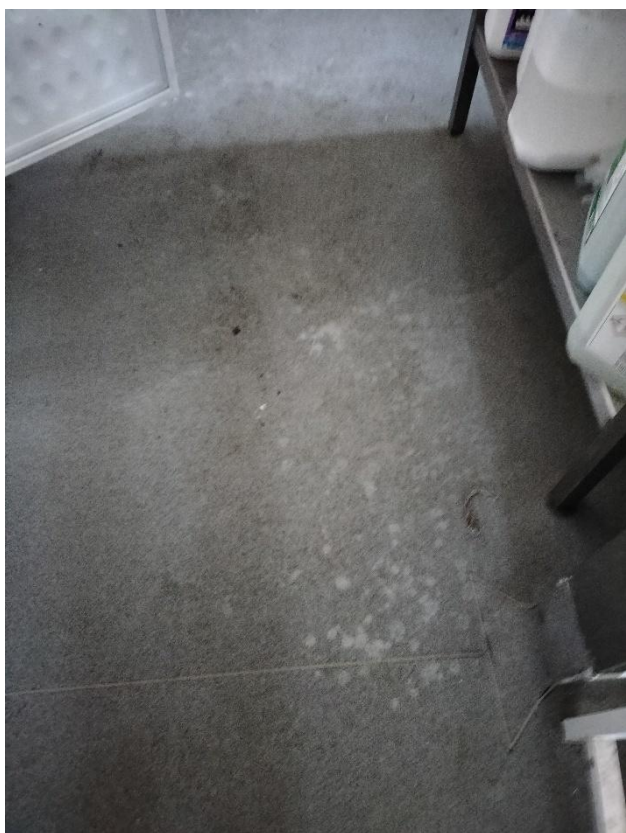
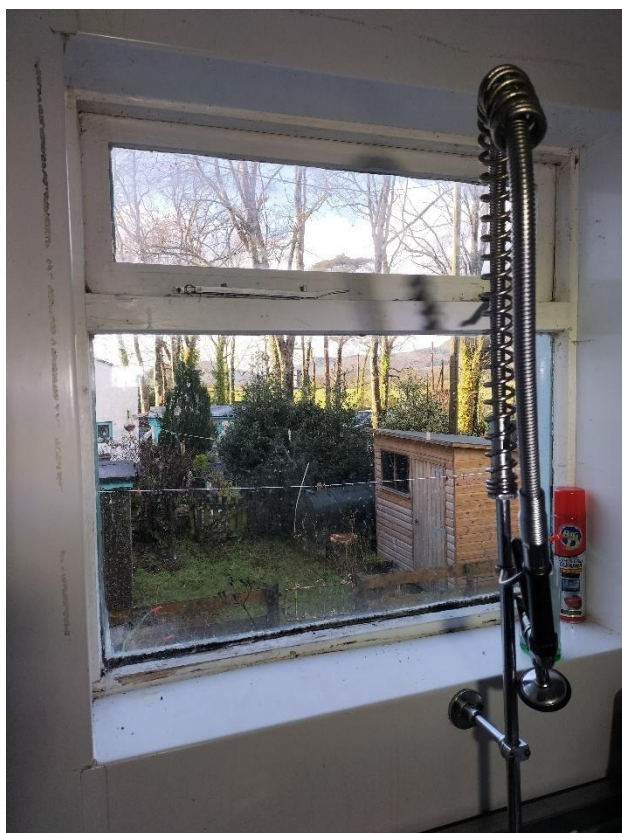
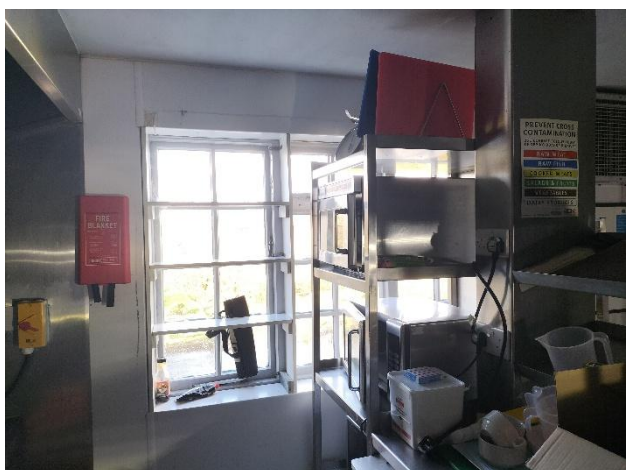
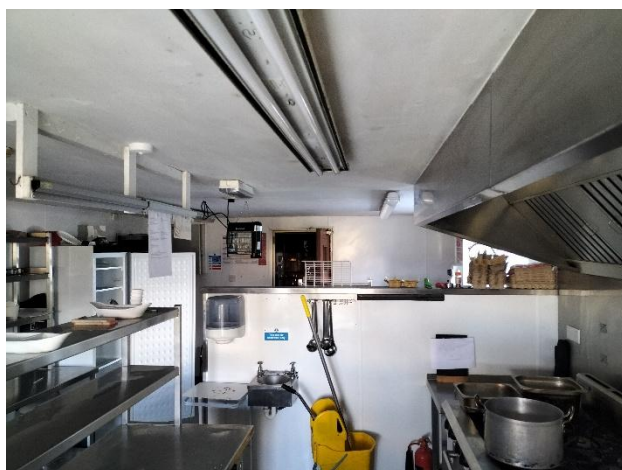
Overview photos:

### 9.2.6 G05 - Cegin

**Ceiling** | Smooth painted plaster on timber joists. Generally in fair condition with evidence of past repairs.

**Walls** | Cavity masonry walls with assumed painted plaster that is clad over with UPVc sheeting. Cladding sheets appear in satisfactory condition but is beginning to look a little tired along the edges.

**Floor** | Suspended timber floor with vinyl sheet flooring finish and coved skirtings. Vinyl is largely stained and generally tired and is reaching its life expiry.

**Windows** | Three painted timber windows. Small modern single hung window on south wall appears like it's reaching its life expiry with failing decoration and glazing putty, tired ironmongery, and early signs of rot. Refer to section 8.6.2 for description of external condition.

**Door** | Two single leaf plain solid timber fire doors with varnish finish, vision panel at high level and modern ironmongery. Generally in satisfactory condition but is unsympathetic with tired looking ironmongery.

**Features** | Stainless steel commercial kitchen extractor and equipment. Generally in satisfactory condition but will need degreasing and may need to be replaced in its entirety in near future.

- Overhaul sliding sash windows as described in section 8.6.4.
- Replace small modern single hung window with window that is more sympathetic.
- Remove UPVc cladding sheets and redecorate walls with suitable semi-gloss wipeable paint.
- Consider replacing fire doors with a more sympathetic design.
- Degrease and deep clean kitchen extractor and all other equipment in short term.
- Replace commercial stainless steel kitchen with new within next 5-10 years. Redesign layout so that sliding sash window is no longer obscured.

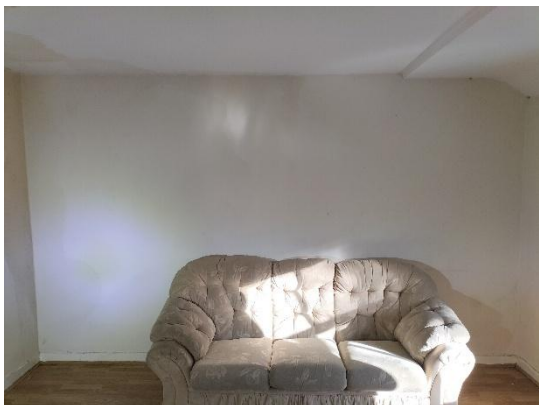
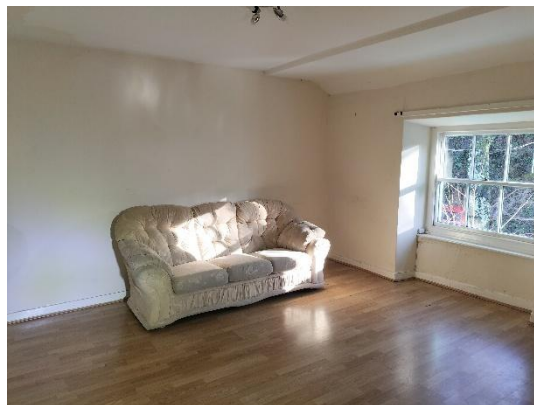
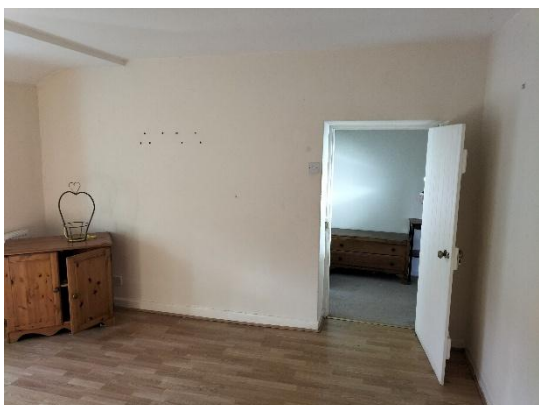
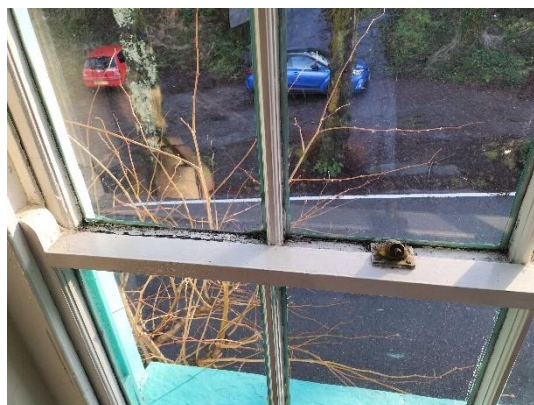
#### Overview photos:

### 9.3.1 F01 – Ystafell Fyw

- Further investigate damp issue suspected to be related to water ingress through chimney stack and/or gable wall.
- Redecorate walls with suitable breathable masonry paint.
- Consider removing modern laminate and replace with engineered wood floor or sand and coat over existing floor boards. Level up floor and introduce acoustic and fir resistant flooring system.
- Redecorate door and allow to renew or replace ironmongery that is more sympathetic such as antique brass.
- Improve ventilation by occasionally opening window once eased.

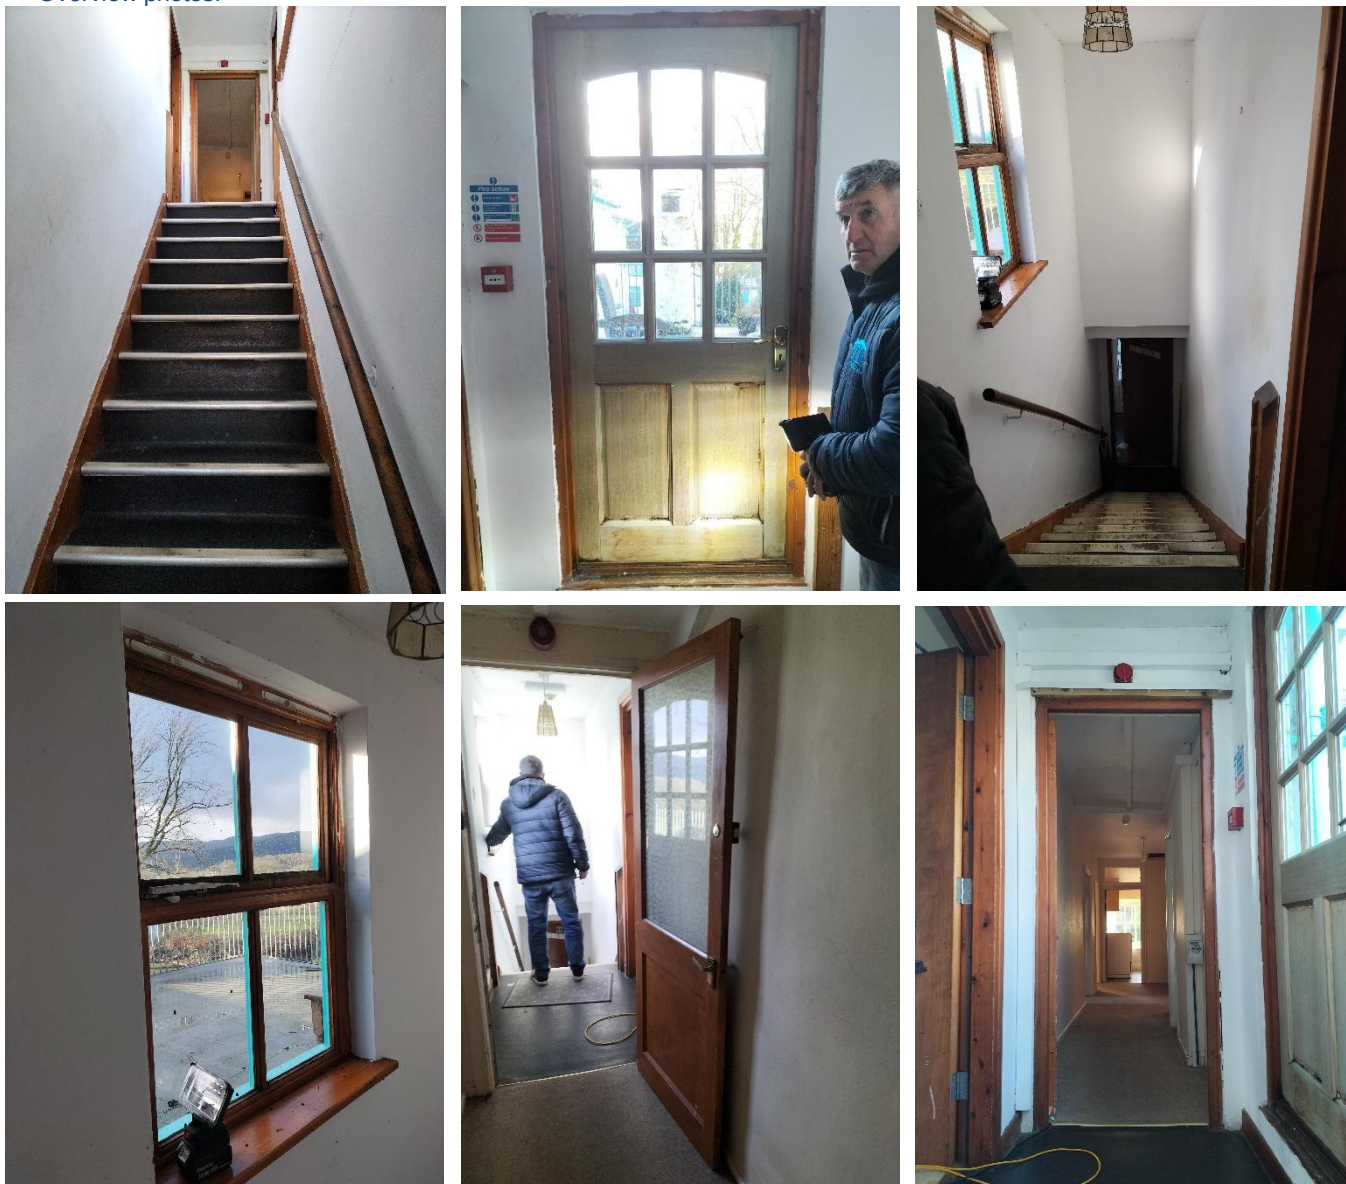
#### Overview photos:

### 9.3.8 F08 – Staircase, Landing & Circulation Passage

- Replace staircase nosings.
- Consider replacing ironmongery with antique brass.
- Board over/skim ceiling.
- Redecorate walls, ceilings and skirtings.
- Consider replacing carpet with either carpet or engineered wood flooring.
- Consider levelling up floor and introduce acoustic and fire resistant flooring system.
- Restain window surfaces and consider replacing ironmongery with new antique brass to more sympathetic style.
