Outline Condition Survey of Brondanw Arms / Tafarn Y Ring, Llanfrothen

Date of Inspection: 06 January 2025  
Weather Conditions: Light rain, cold 3°C

Issue date: 04 February 2025  
Prepared by: Gethin Roberts  
Checked by: Iwan Thomas

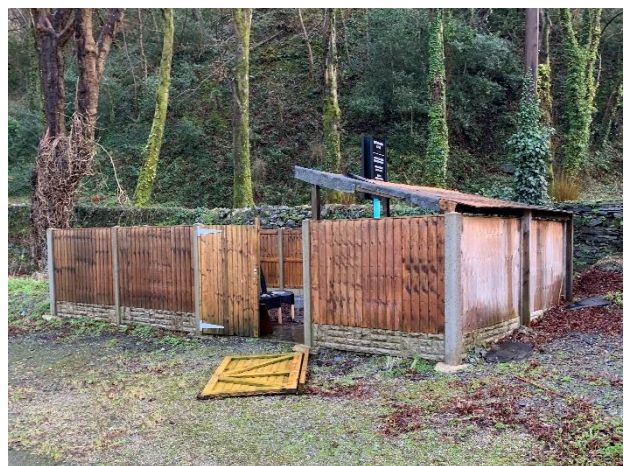
The bin and recycling compound looks tired and has deteriorated to the point that it needs to be replaced.

Bin, recycling and storage compound adjacent to car park.

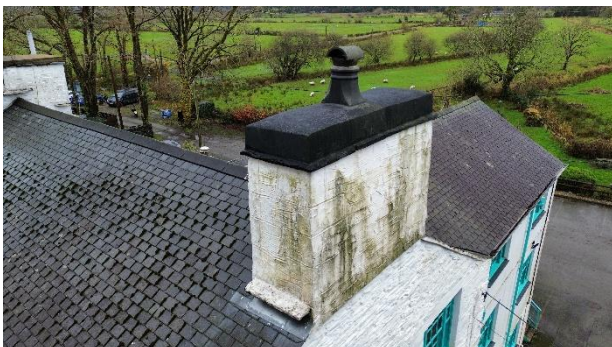
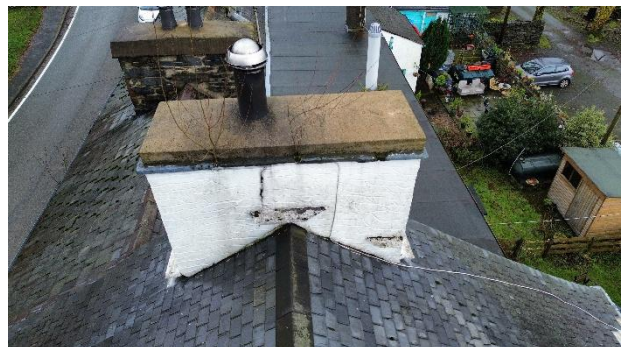
Render to north gable stack is heavily stained below concrete capping which is suspected to be contributing to damp issues to northern gable wall. Render to both stacks are unsympathetic and detrimental to the character of the building. Render appears in sound condition but is suspected to be cementitious plaster that is likely to be withholding moisture that may be contributing to the damp issues to the northern gable wall. Concrete capping to southernmost stack has cracks visible that may be allowing water into the stacks' masonry.

- Hack off render and rake out mortar joints.
- Re-point with traditional lime-based mortar.
- If stonework is in good condition then limewash over with 4no coats. If not, dub out and render over stonework with traditional lime-based plaster.
- Allow to replace concrete capping to southernmost stack with NHL5 lime mortar.
- Line stacks / flues with lime-based mortar.
- Allow for new flues and vented caps.

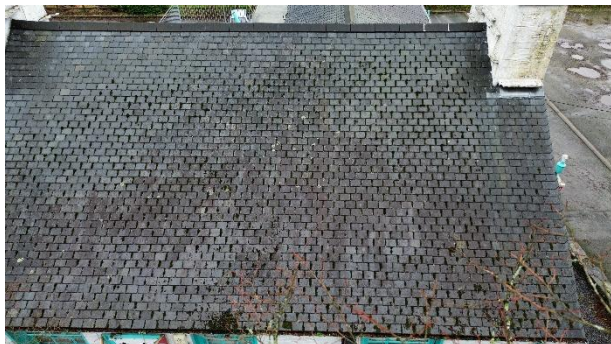
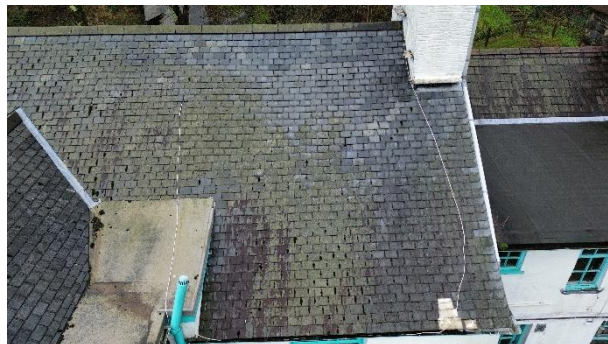
### 8.3.1 Main / Original Building

Heavy moss growth and some lichen visible, especially to the front (eastern) pitched slope. Rear (western) slope cover and ridge tiles are also showing heavy weather / biological growth staining, which is expected due to close proximity of trees along highway. There is also evidence of several localized repairs to the rear slope with lead cleats visible which suggests possible nail sickness / failure – this is likely to result in the need to re-roof the entire slope within the next 5-10 years as the roof slope is nearing its life expiry. Some ridge tiles have also been re-bedded towards the northern end of the ridge as fresh mortar joints are visible. The roof structure seems to be relatively modern and in good condition with very little of the original roof structure remaining, mainly perkins which are doubled up with new members. Mineral wool insulation appears in satisfactory condition but may need additional insulation to reach suitable standards for accommodation. Suspect that roof void currently does not have sufficient ventilation, which could lead to the decay of the roof structure.

- Clean off all moss and biological growth from roof cover.
- Re-roof entire rear slope. Allow for new roofing sheet membrane. May need to be Type 1F felt if presence of roosting bats, which will also require form of clear ventilation between eaves and ridge levels. Lead vents may need to be provided if eaves and ridge vents alter the external appearance of the roof.
- Re-bed all ridge tiles with NHL3.5 lime mortar.
- Structural Engineer to assess structural integrity of roof structure. New ceilings joists and roof ties especially to be thoroughly examined.

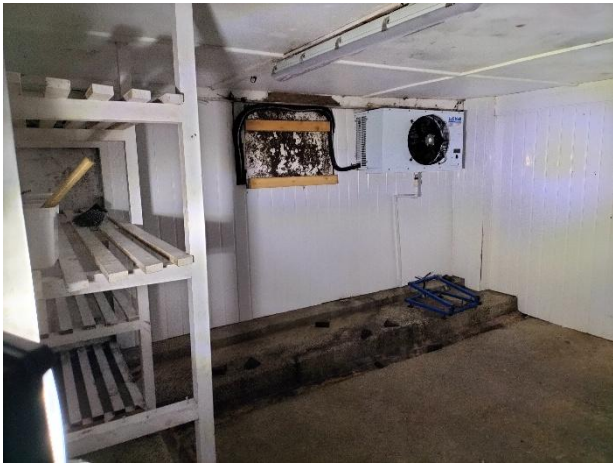
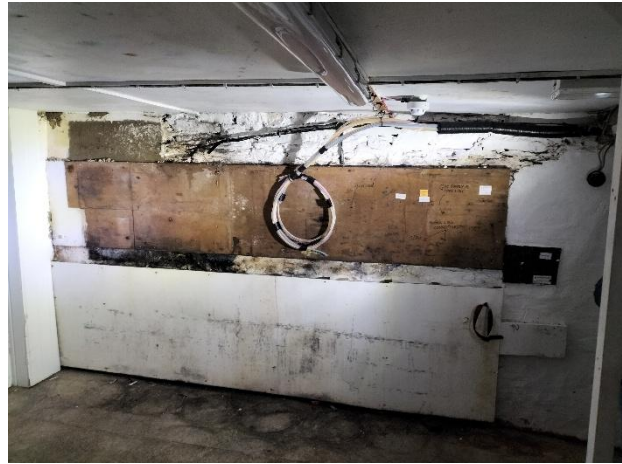
The condition of the walls within the cellar section of the original building is a concern at present as there is significant mould growth present to the external walls' surfaces. This is directly linked to the issues present to the external face where the passage of moisture is being restricted due to impervious materials (mortars, plasters and paint). Furthermore, a lack of ventilation is accelerating the issues with mould and biological growth therefore mechanical ventilation could help alleviate this problem and provide better air quality.

- Remove UPVc cladding boards and ply sheets from walls and ceilings.
- Consider board over ceiling with fire-resistant plasterboard with painted skim finish.
- Introduce mechanical ventilation into space to improve ventilation and air quality, which will help with drying out walls and prevent mould growth and condensation.
- Remove impervious paint and mortar joints to external masonry walls and repoint with traditional lime mortar.
- Redecorate walls with breathable masonry paint such as limewash.

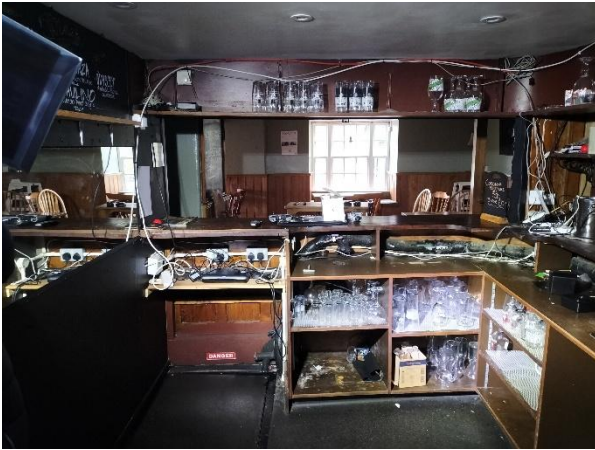
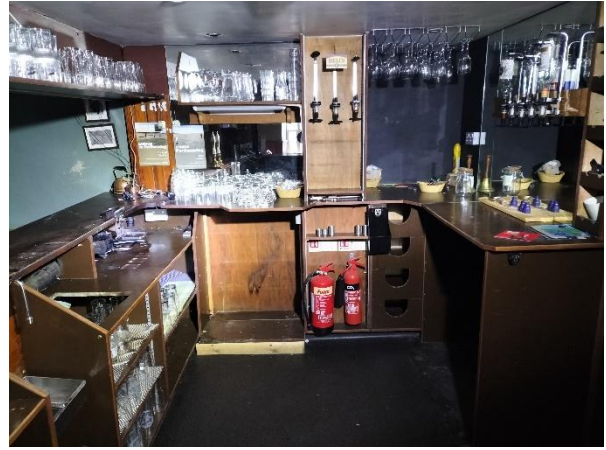
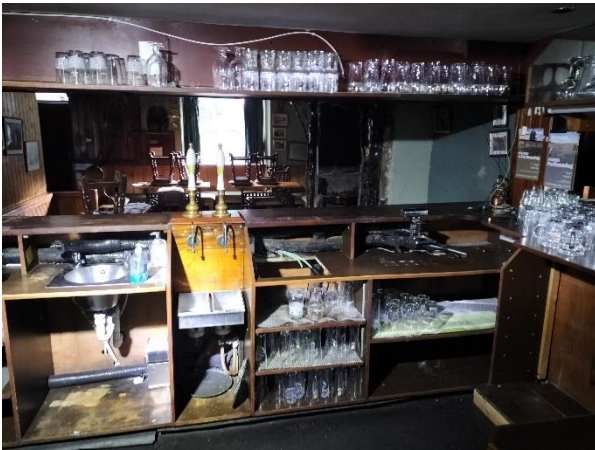
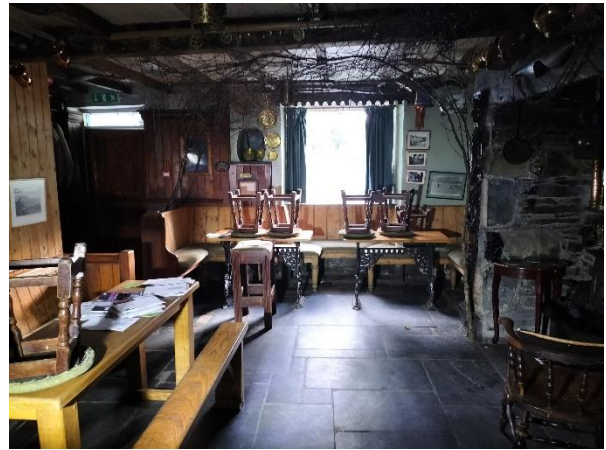
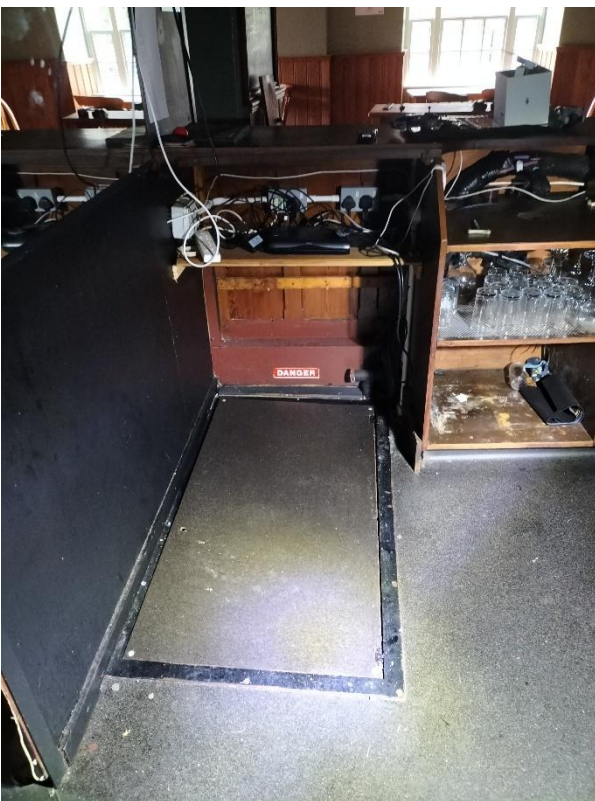
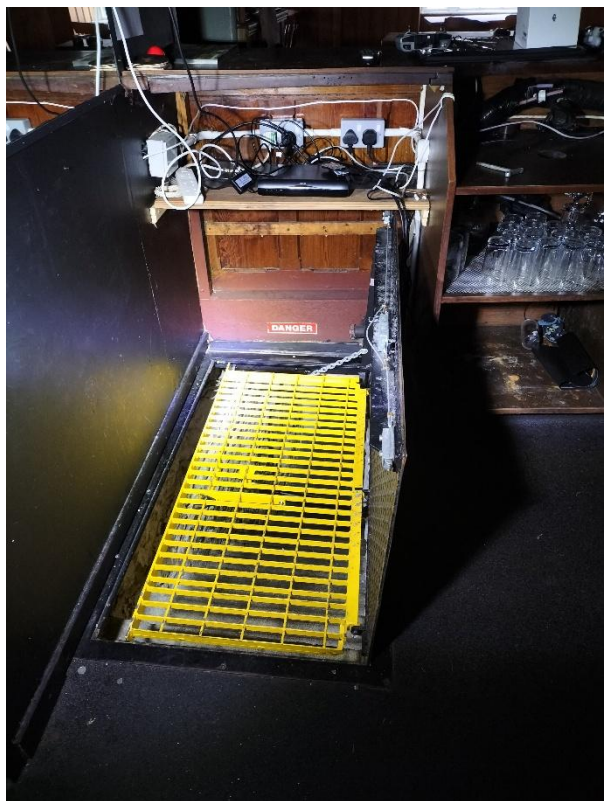
### 9.2.3 G03 – Bar

**Ceiling** | Smooth painted plaster on timber joists. Generally in good condition.

**Walls** | Solid, mass masonry walls with plaster finish that's papered over with painted woodchip wall paper and largely obscured by wooden paneling and mirrors therefore it was not possible to assess condition of walls. Paneling and shelving appears tired and worn with a lot of staining visible.

**Floor** | Suspended timber floor with assumed timber sheet deck. Vinyl sheet flooring finish with mixture of coved and modern timber skirtings. Vinyl is in fair condition and is a little worn in places and largely stained all over.

**Door** | Single leaf plain solid timber fire door with varnish finish, vision panel at high level and modern ironmongery. In satisfactory condition.

**Features** | Varnished timber paneling to exterior of bar and timber worktop along the frontage of the bar in good condition considering their age. Cellar hatch with gas strut assistor. Hatch is in two layers with a solid wooden panel lid finished with vinyl matching the floor finish that closes onto a painted steel mesh base, both of which are held open with gas strut assistors and are in good condition.

- Replace vinyl flooring with similar new waterproof flooring. Assess condition of deck and allow to replace if necessary.
- Clean internal paneling and shelving. Although they are fine to use in the short term, they will need to be upgraded within the next 5-10 years.
- Consider replacing fire door with a more sympathetic design.
